RE: Progress report for February 2007 activities - Hecla Mining Company Apex Site (EPA ID No. UT982589848, Docket No. RCRA-8-99-06)

SUBJECT: **Progress Report No. 34 for period ending February 28, 2007; Pond 2 Final Closure - Apex Site, Washington County, Utah**

TO: Paul Glader (Hecla Mining Company)
FROM: Doug Gibbs (Monster Engineering Inc.)
DATE: 2/20/07
SUBJECT: Surface Monument Survey Data Review – Apex Site

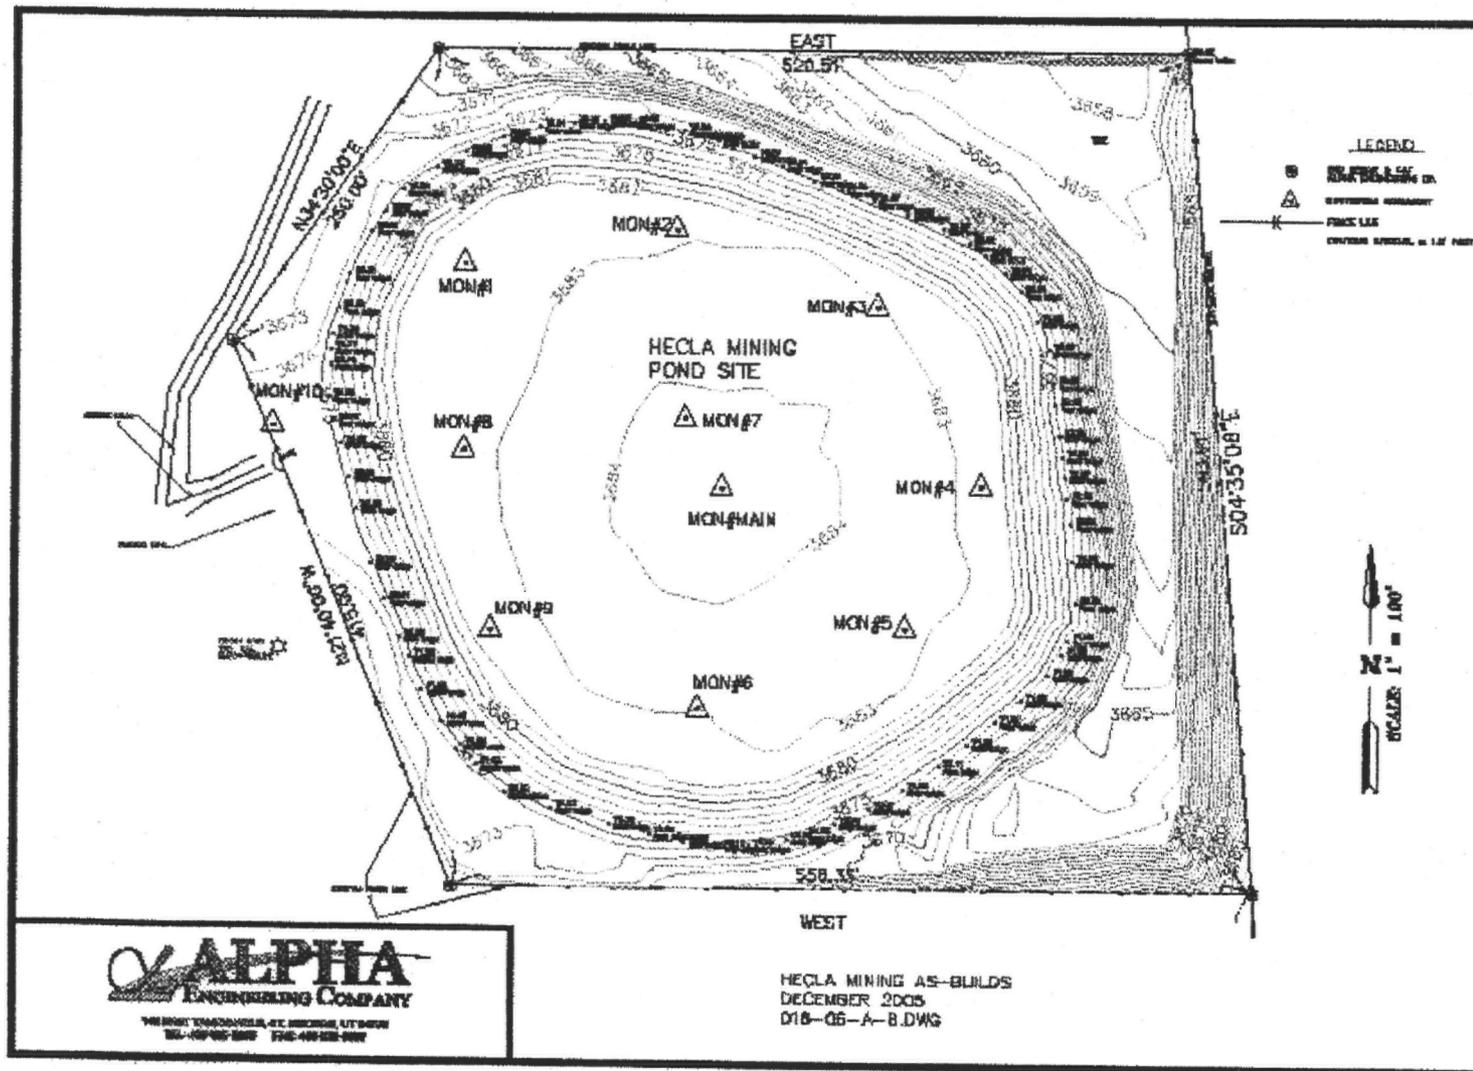
Apex Pond 2 - Settlement Monument Elevations

Based on data collected to date, MEI recommends that Hecla continue with their current plan and collect elevation data quarterly. Please call or email me if you have any questions concerning this review.
